# Manhole Inspection Summary

Manhole # S41I\_\_018MH

Insp Date: **5/14/08 11:30 AM**

**Location** Address: **1400 gough st**

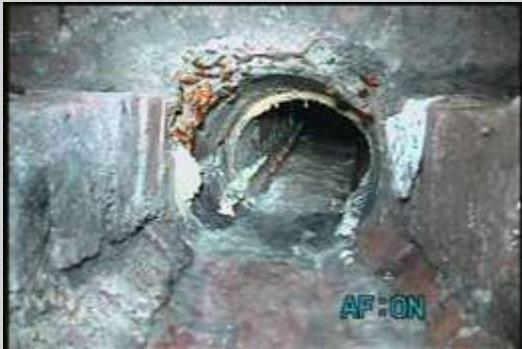
12 O'Clock Outflow

8 in. Circular Gravity Sewer  
Pipe Out @ 12 O'Clock

Infiltration: **None** Pipe Seal Cond: **Unknown**
